**Specific Site Assessment for
Coal Combustion Waste
Impoundments at Duke Energy
Carolinas Lee Steam Station**

Williamston, South Carolina

GEI Consultants, Inc.
4601 DTC Blvd., Suite 900
Denver, CO 80237

July 2010
Project 092881

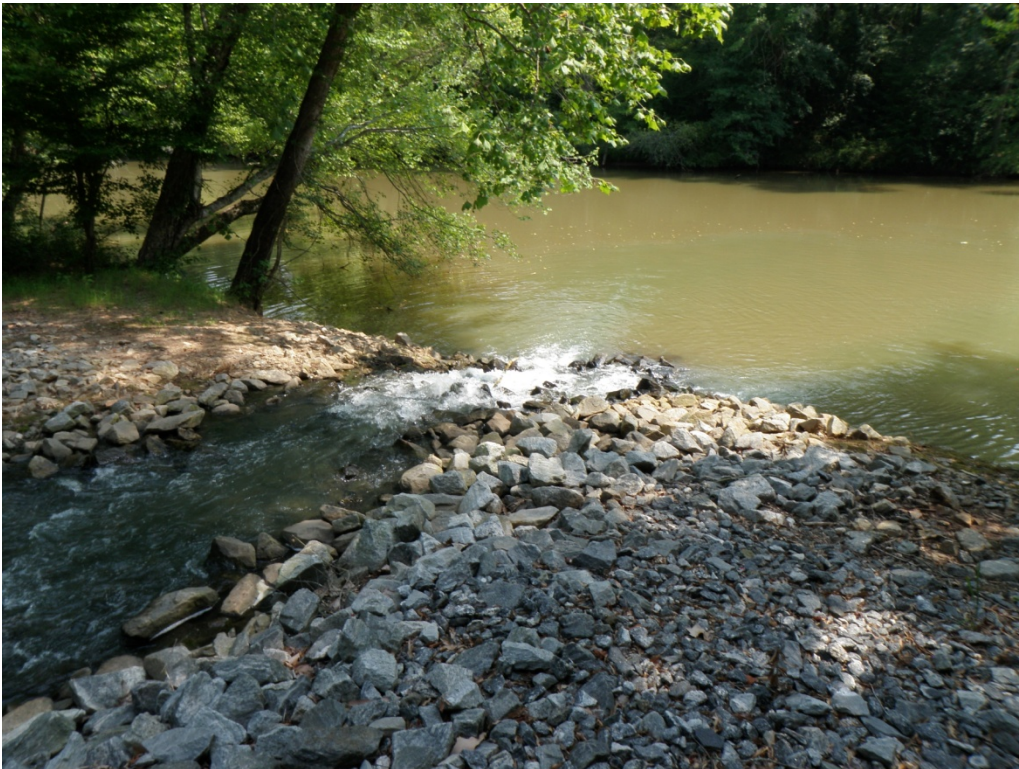
Photo 28 – Secondary Ash Basin outlet works – discharge channel to Saluda River.

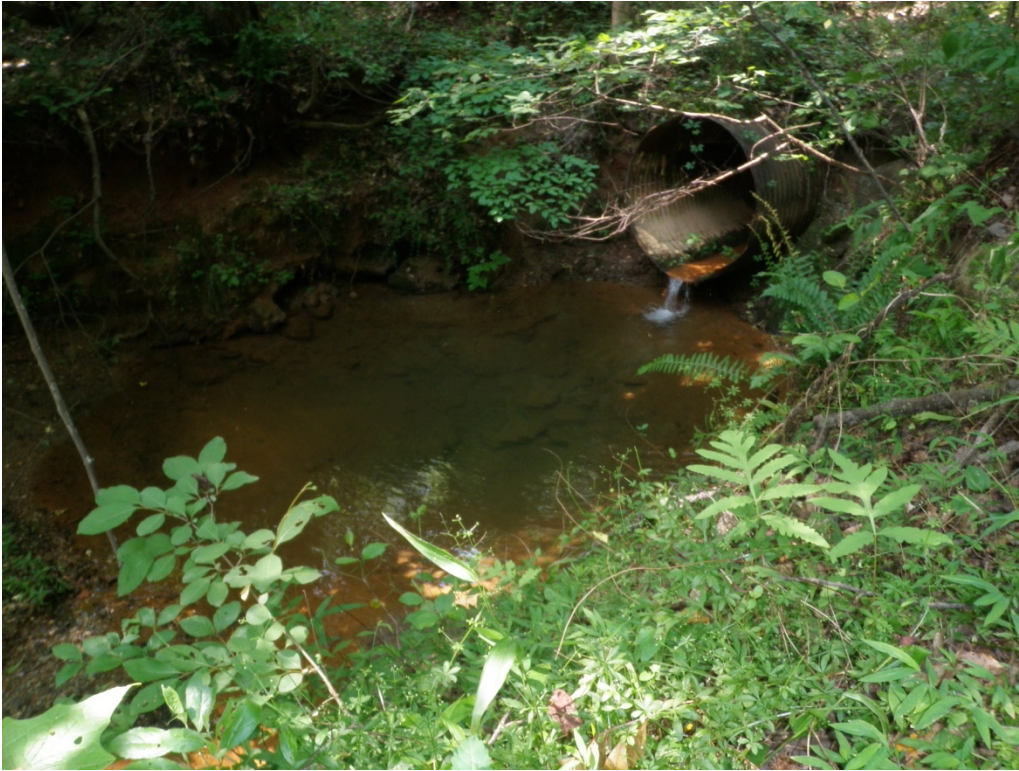
Photo 29 – Secondary Ash Basin toe drain outlet.
